## City of Abilene

### Landmarks Commission Agenda

# CERTIFICATE OF APPROPRIATENESS

## CASE CA-2020-03

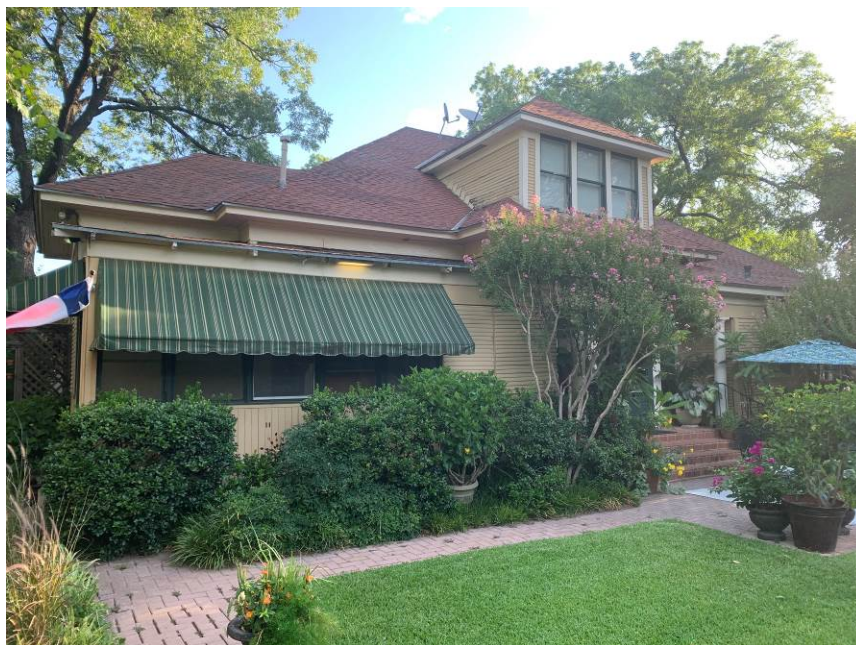
*Figure 1: View of Damaged Porch*

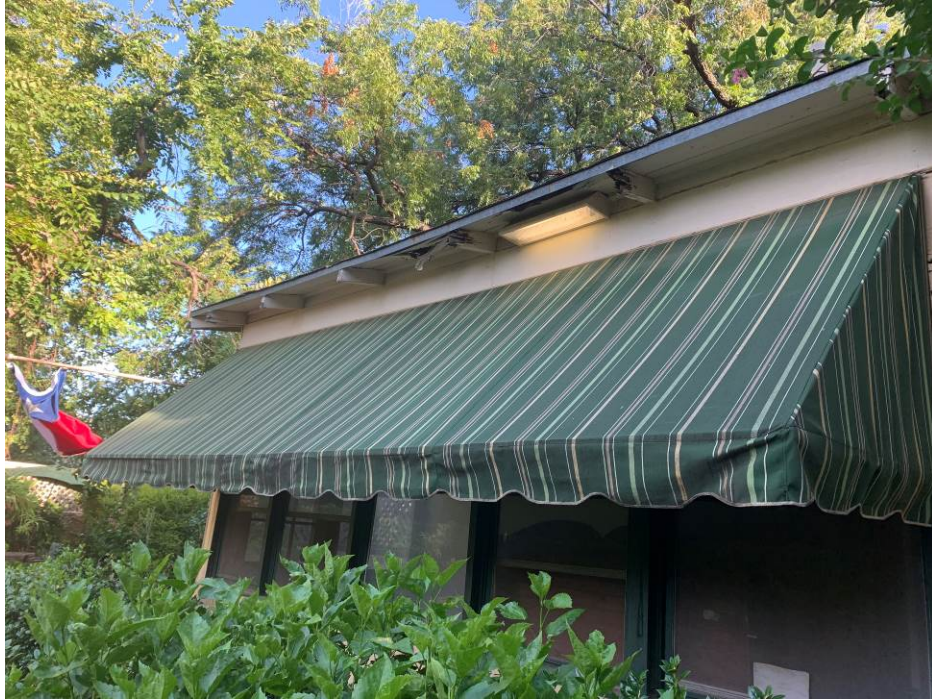
*Figure 4: View of damaged porch*

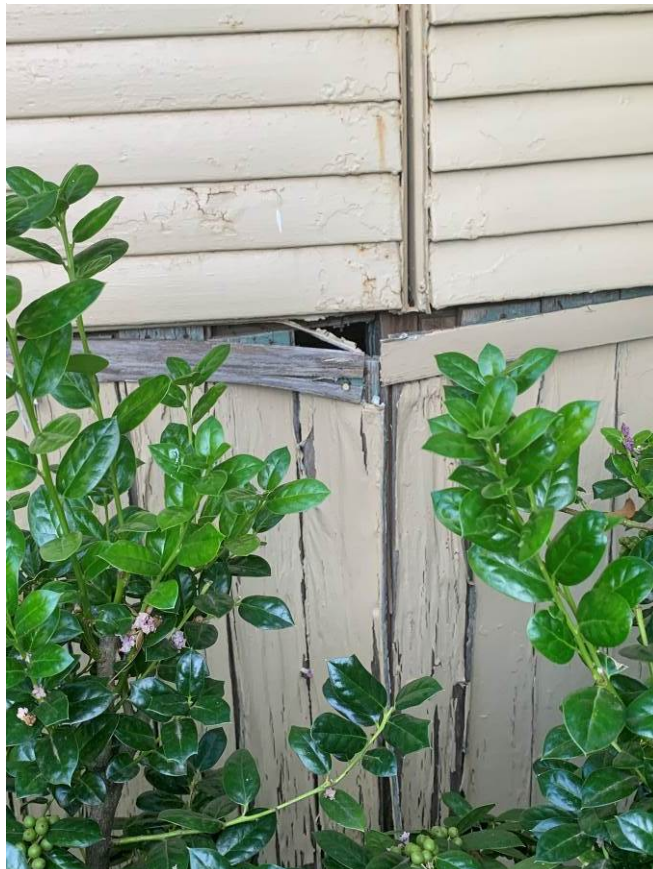
*Figure 3: Damaged wood siding*

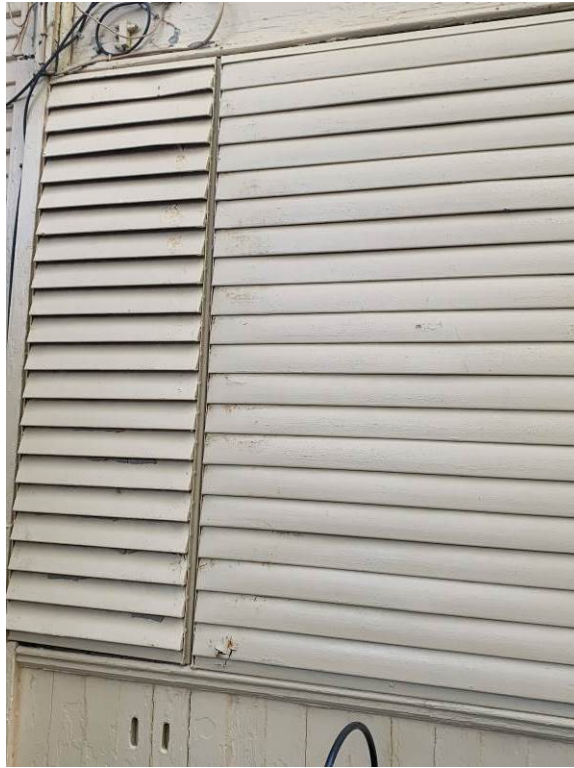
*Figure 5: Rusted shut metal shutter siding*

*Figure 6: Proposed wood siding to replace metal shutters*

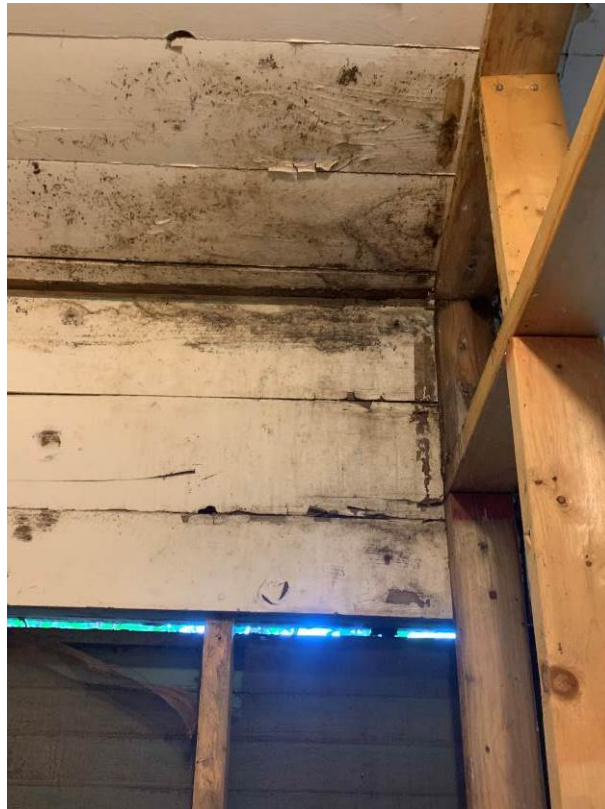
*Figure 8: Porch interior view of damaged roof*

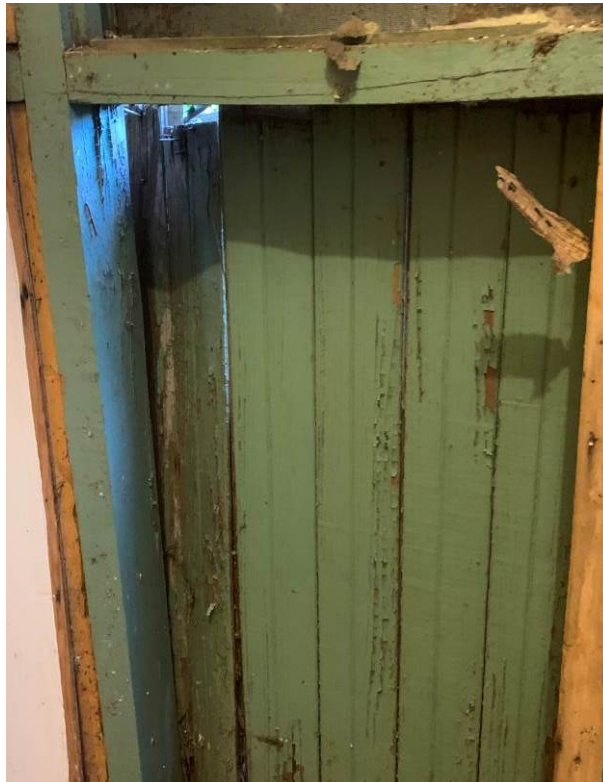
*Figure 7: Porch interior view of damaged wood siding*

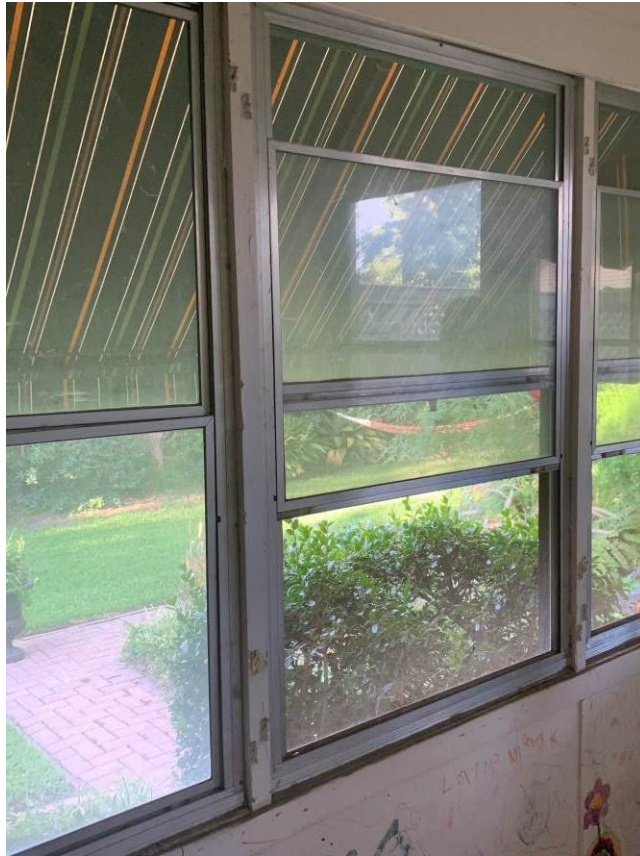
Figure 10: Aluminum windows

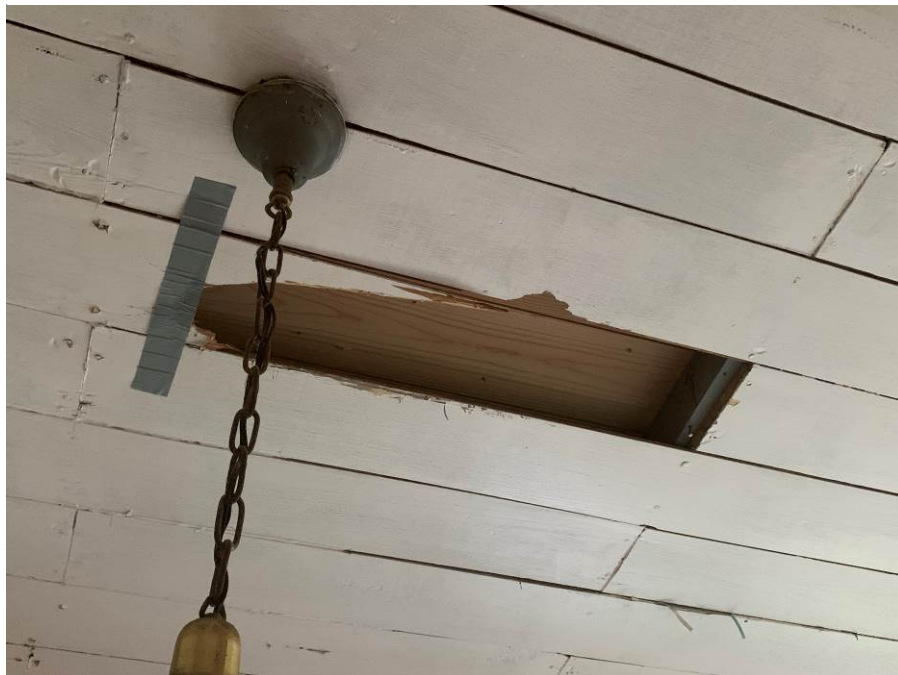
Figure 9: Porch interior view of damaged roof

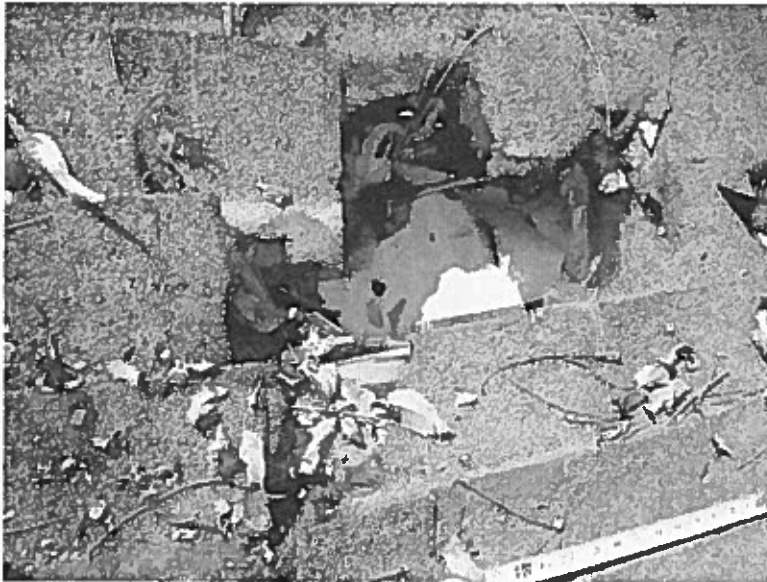
*Figure 3. Tree damage penetration through roofing and roof sheathing (white duct tape is on the ceiling surface).*

- Replacement of the porch structural roof deck boards with plywood a minimum of 5/8 inch thick.
- Replacement of the porch roof underlayment (in your bid use one layer of self-adhered "Ice & Water Shield" type underlayment (see GAF's version attached) stuck down ***directly to the wood deck (no other underlayment is necessary) instead of nailed felt underlayment***)

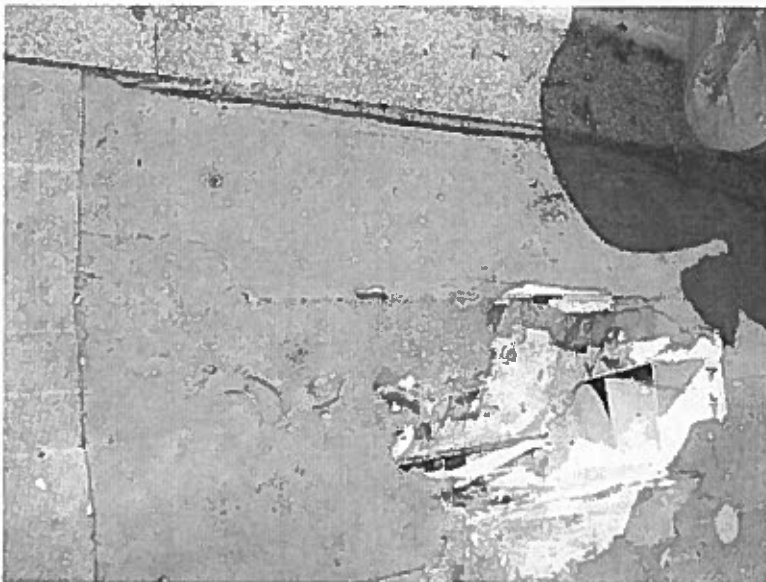
*Figure 4. There were two layers of felt underlayment with the bottom layer hot mopped (due to the low slope of the roof).*

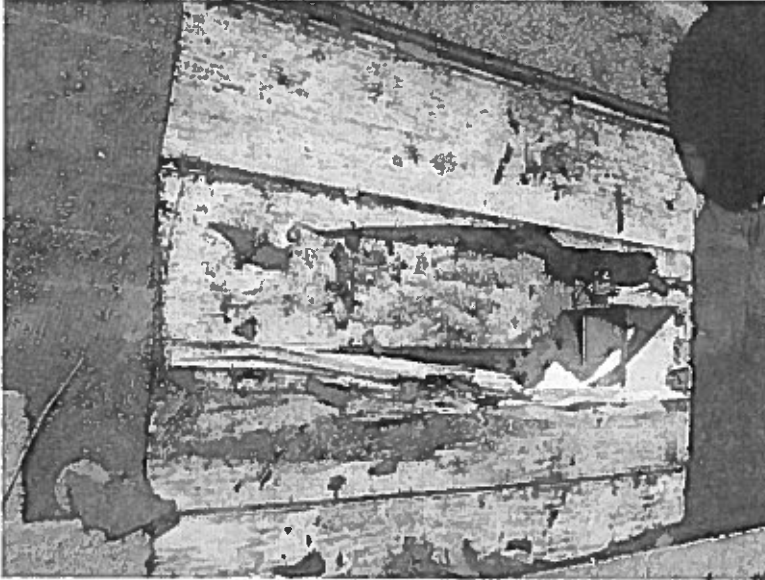
*Figure 5. Fractured 1X8 tongue and groove roof sheathing.*

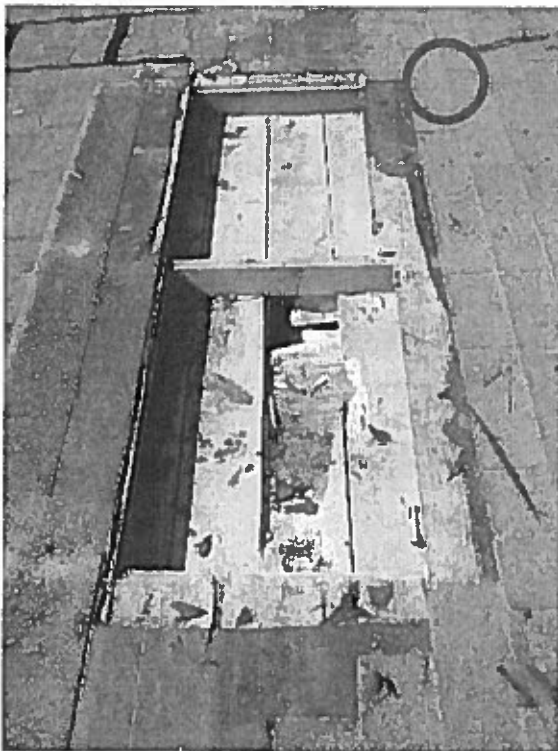
*Figure 6. Expanded exploratory opening with location of fractured rafter in red circle.*

*"The fractured 2x4 rafter in the west portion of the roof should be removed and replaced with a new rafter. We observed deflection in the western portion of this roof, and because it is unclear whether any of the other porch rafters have been damaged as a result of the recent tree impact, WJE recommends that the contractor performing the replacement of the cracked rafter expose and determine if any of the other rafters west of this area are also cracked. If additional damaged rafters are discovered, these rafters will require repair or replacement as well. Replacement of rafters will require that the interior gypsum ceiling board finishes (fastened to the underside of the rafters), structural roof deck boards, roof underlayment, and shingles associated along the full length of the rafter(s), including extending over the full length of adjacent rafters, must also be removed and replaced. Note that the damaged structural deck boards require replacement with span-rated sheathing of like thickness as the existing boards. The new structural roof deck boards are required to be installed in a minimum two-span continuous configuration (extending across two spans between rafters)."*

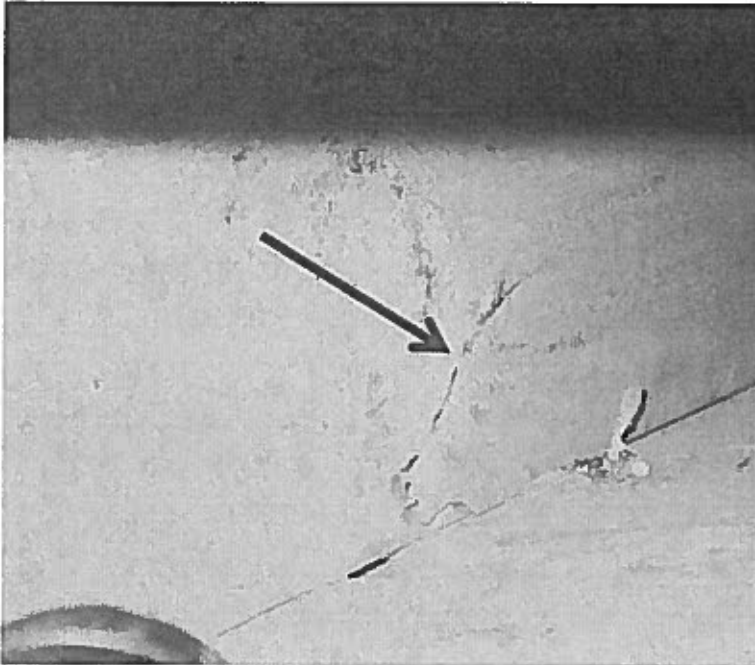
*Figure 7. Fractured rafter.*

*"In conjunction with the rafter repair/replacement, all new rafters will need to be fastened to the top plate of the south exterior wall and at the ridge/ledger at the north wall of the residence to meet code."*

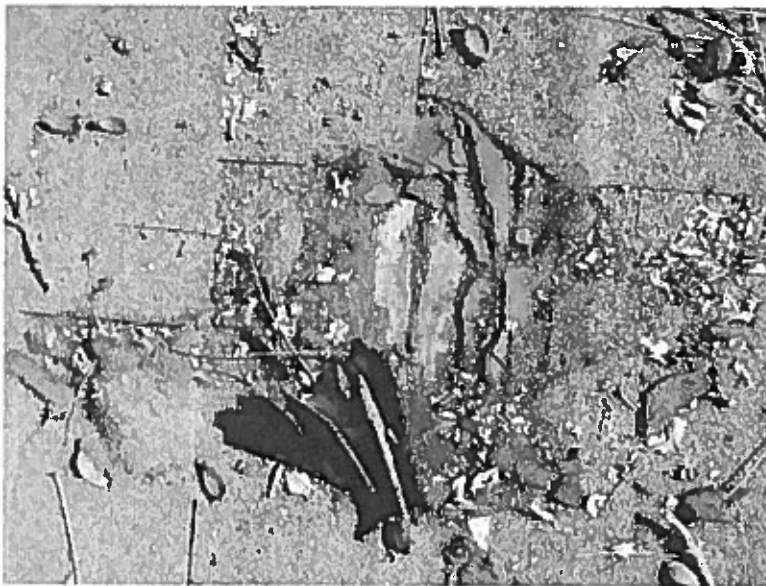
*Figure 8. Roof damage with possible underlying structural damage.*

*"Though it is currently concealed by the roof deck and interior finishes, there is potential that the porch north perimeter ridge/ledger board support member was damaged, and the ledger board fasteners loosened by the impact of the tree limbs on the roof. During the replacement of the fractured rafter(s), this support member and associated anchorage should be exposed and inspected to determine whether any repairs are required."*

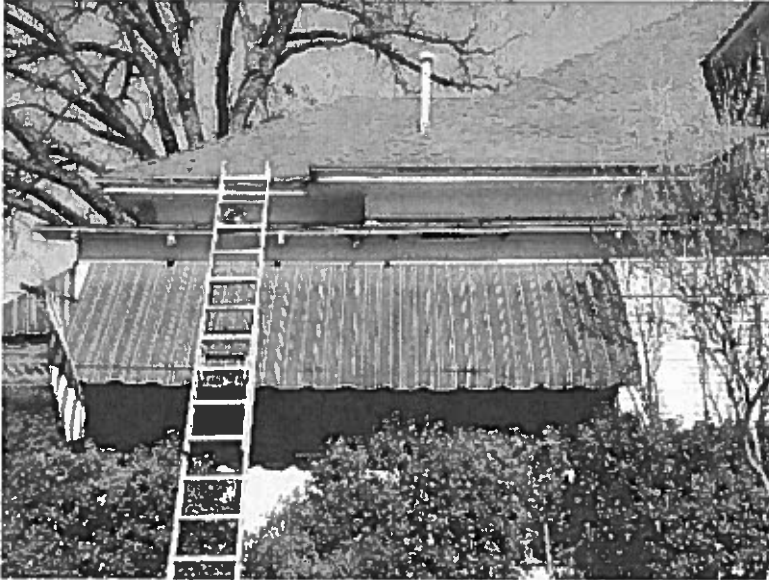
*exterior wood soffit ceiling boards, and the interior gypsum ceiling and wall board finishes. This damage also includes deflection of the roof structure in the east/west direction along the south eave, and deflection of the western portion of the roof structure in the north/south direction of the roof rafter span."*

*Figure 9. Deflection in eave of porch roof below damage (approximately at ladder).*

*"it may be necessary to replace all of the porch rafters in order to meet the requirements..."*

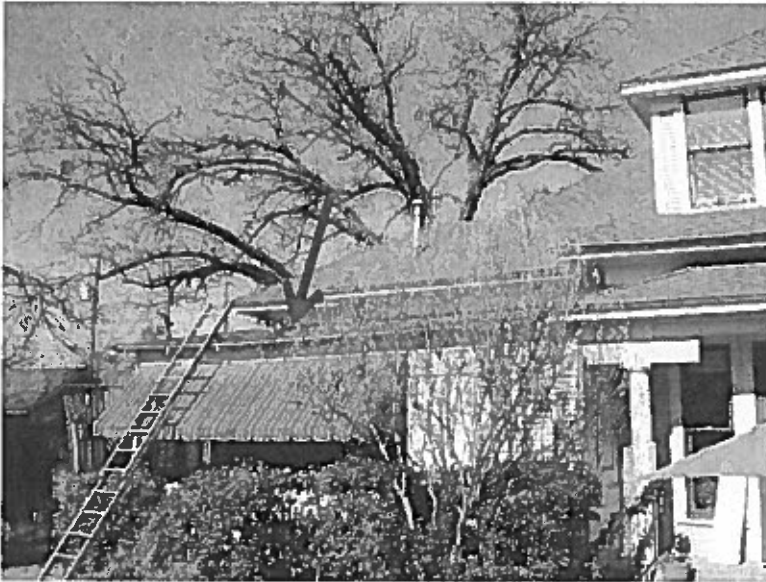
*Figure 10. Deflection visible between lower eave and upper ridge of porch roof.*

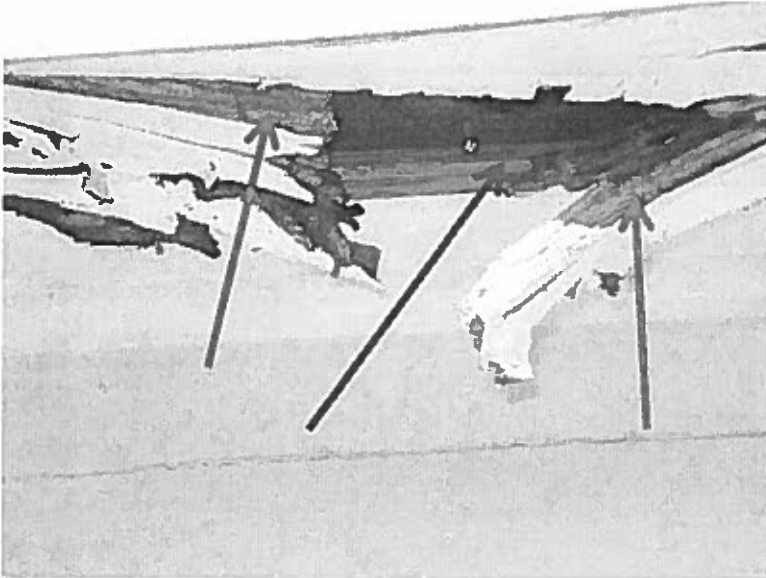
*Figure 11. Bright fresh wood (red arrow) indicating recently exposed wood, possibly from tree impact, compared to the older oxidized gray-colored wood (green arrows).*

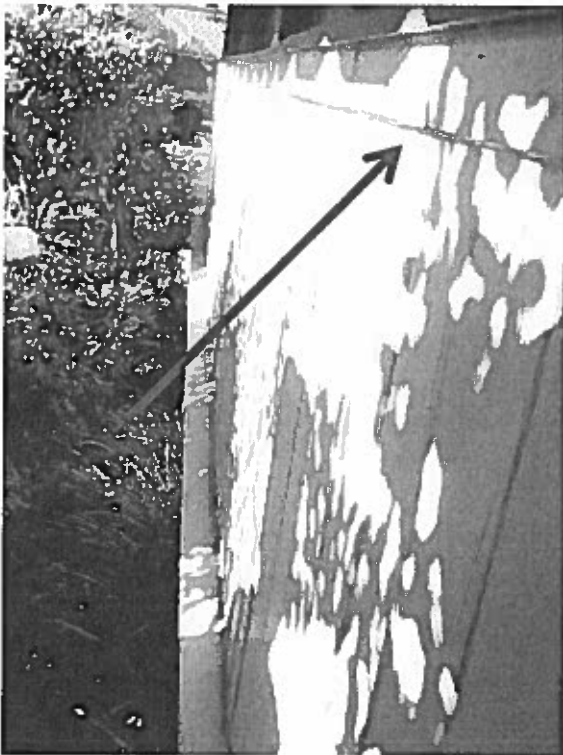
*Figure 12. Inward bow in wall of porch.*

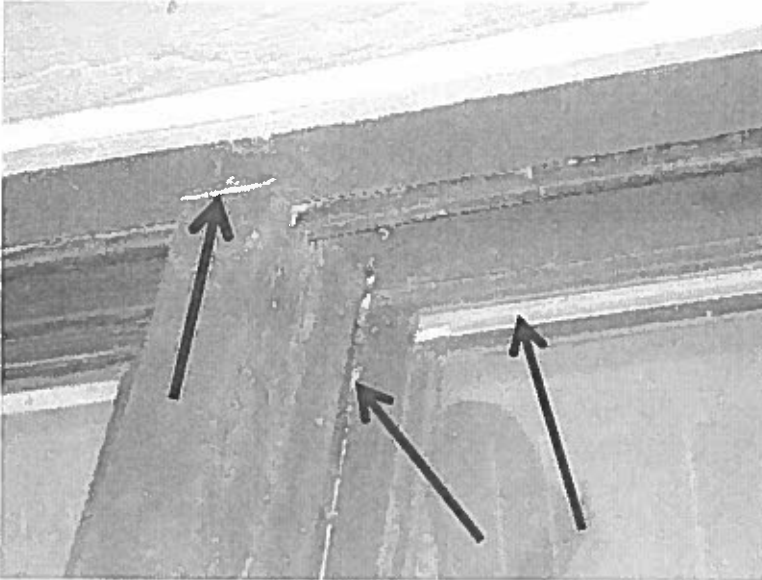
*Figure 13. Indications of impact - recently exposed white paint and damaged/displaced window.*

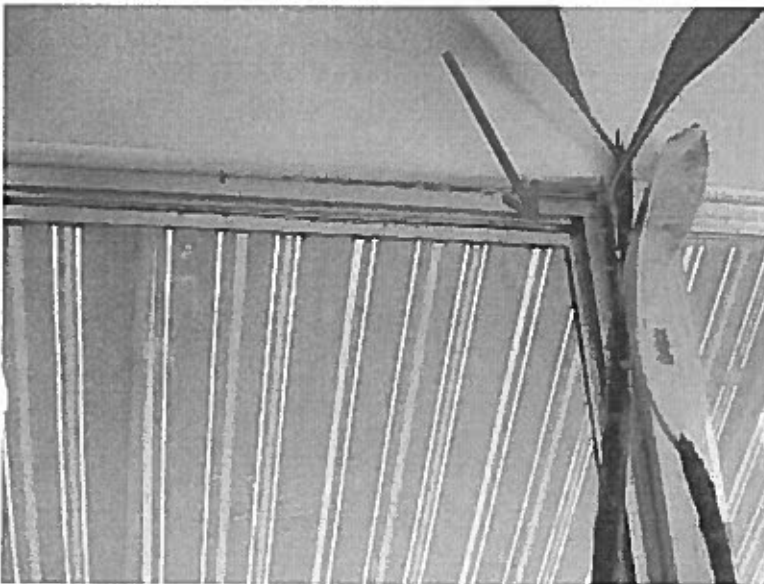
*Figure 14. Damaged/displaced window from the interior of the porch.*

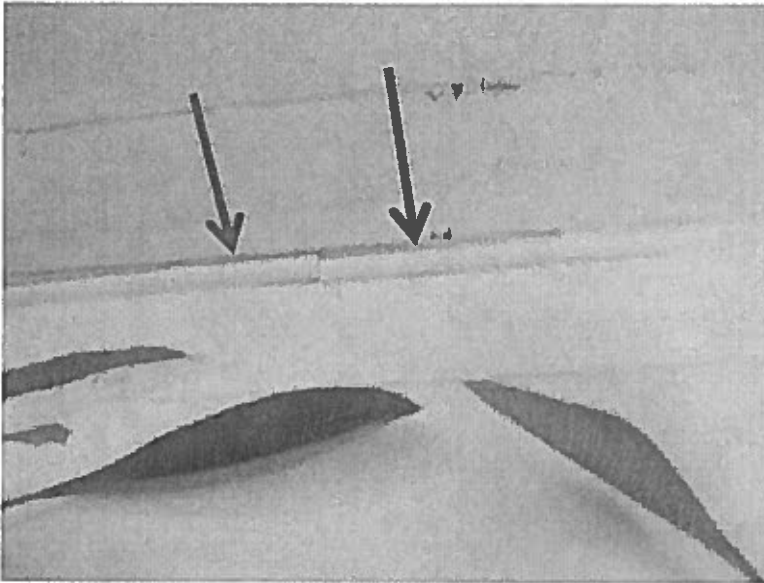
*Figure 15. Tree impact has damaged interior trim.*

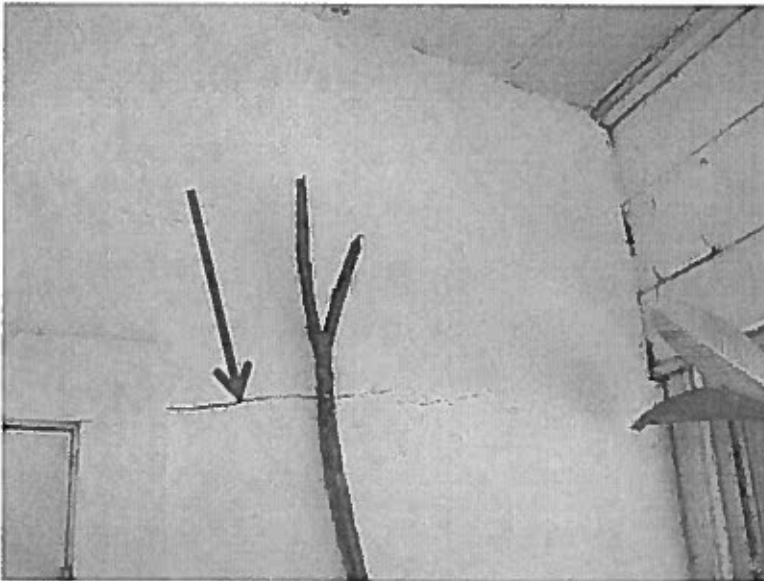
*Figure 16. Fresh impact damage to wall of closet (at east end of porch).*

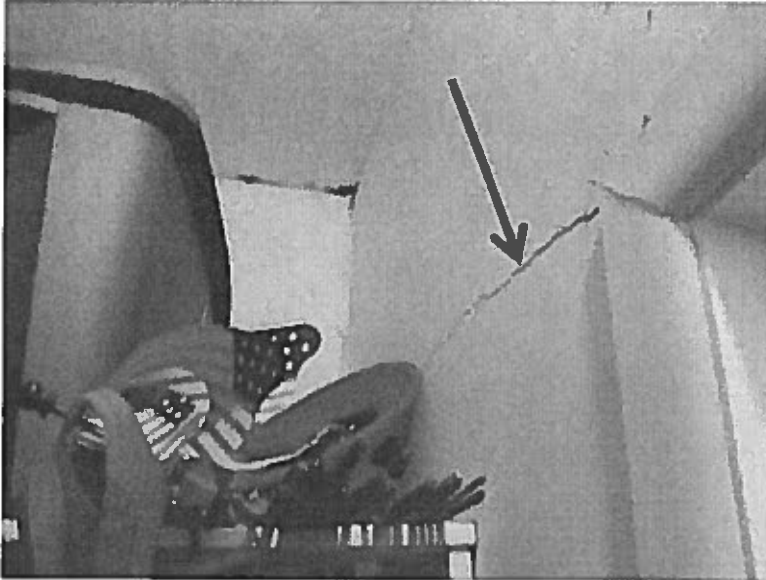
*Figure 17. Fresh impact damage to interior wall of closet.*

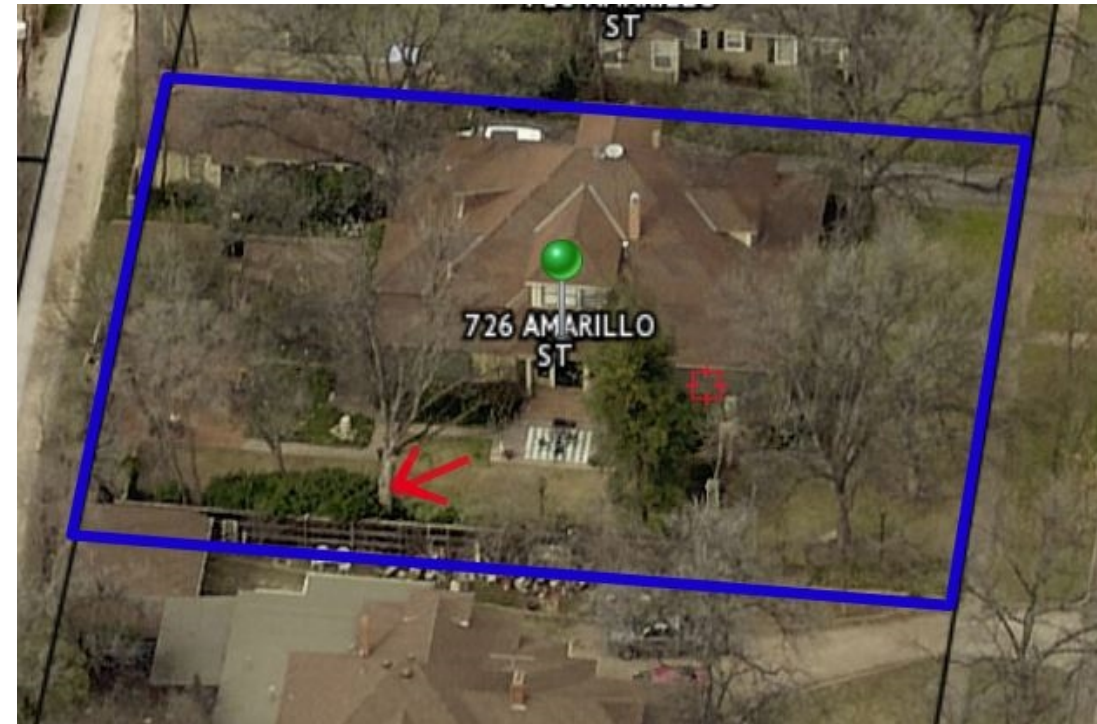
Aerial View of property indicating fallen tree location
