## **City of Abilene Parks and Recreation Board Agenda**

**Notice is hereby given of a meeting of the Parks and Recreation Board of City of Abilene to be held on March 17, 2020 at 8:30 a.m. at City Hall, 555 Walnut Street, Council Chambers, Abilene, Texas, for the purpose of considering the following agenda items.**

# ABILENE INDOOR RECREATION FEASIBILITY STUDY GOALS

ABILENE RECREATION FEASIBILITY STUDY

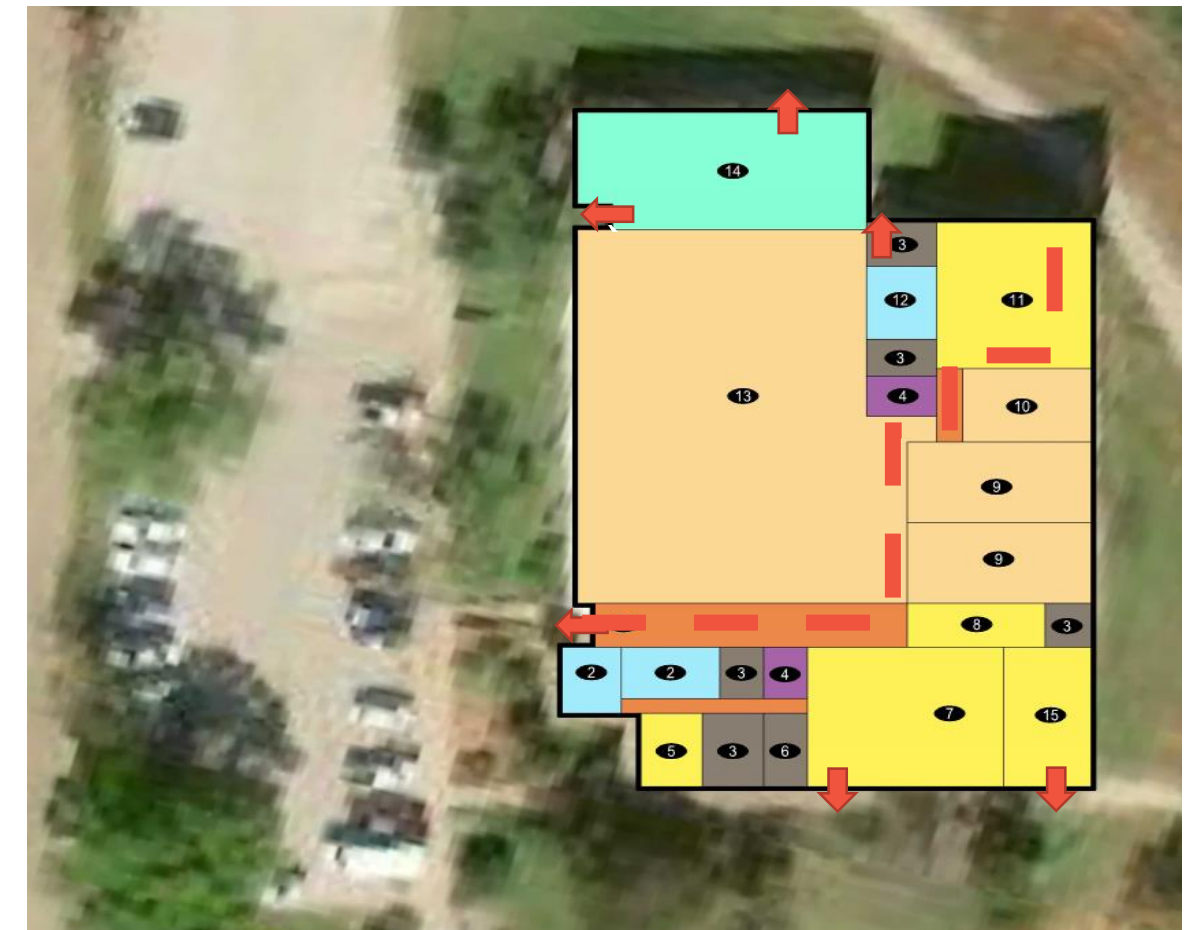
## Sears Recreation Center - Existing Facility Assessment

- **CODE / HEALTH & SAFETY**
  - There is an unoccupied clinic at the north side of the building. Non occupied spaces can be a concern from a health and safety standpoint.

- There are potential egressing concerns from the fitness and multi-use kids' room. The egress pathway to an exit is fairly lengthy and along a circuitous route.

- The building has no fire suppression or smoke alarm system. Due to the size and function of the building likely any new addition or remodel would require the addition of Fire Suppression System.

- **EXTERIOR**
  - Evidence of spalling exterior brick can be seen at a number of locations around the perimeter of the building.
  - Moisture was apparent within the exterior brick. It was not clear if this was coming from the infiltration from weather events, or from inside the wall elsewhere.

- There is a small internal floor change by the gym the is not compliant with accessibility requirements.
  - The existing restroom access point is not TAS compliant. Likely the internal layout may have concerns as well.

- **ENERGY EFFICIENCY/ MAINTENANCE ISSUES**
  - The City noted moderate roof leaking concerns visible at the transition between the arching gym form and the newer flat roof north addition. Roof Drainage concerns were also apparent along the north side of the building exterior walls.

- **USER EXPERIENCE / LAYOUT**
  - The small workout spaces is very dated and separated by a curtain. The Space is not conducive to an efficient and enjoyable workout..

- There is an abundance of fluorescent lighting and minimal natural light for many of the spaces making them less enjoyable to be in.
- The existing basketball gymnasium appears to sized for a high school sized court. The playing surface is not ideal for a competitive basketball game.

- The Sears recreation facility has a number of major concerns that would need to be addressed in the near future as it has reached beyond its useful life. The center plays a critical role to the residents of the neighborhood. The cost to remodel or renovate would be very high knowing that the facility would need to be brought up to current codes. With ample space on site, this facility would be a good location for a new recreation center.

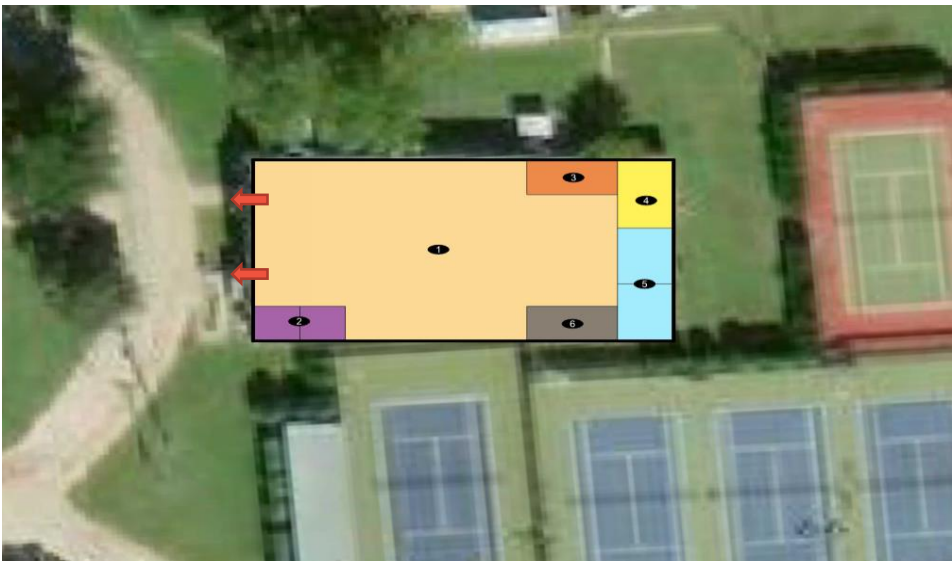
## Rose Recreation Center - Existing Facility Assessment

- **CODE / HEALTH & SAFETY**
  - The overall facilities exits are located on a single side of the building. Current egressing codes require that exits for assembly occupancy buildings meet a separation distance. The current configuration is a concern for health and safety of the building occupants and would not meet current code requirements.

- The building has no fire suppression or smoke alarm system. Due to the size and function of the building likely any new addition or remodel would require the addition of Fire Suppression System.

- The basketball court appears to be a middle school court size. With the existing building structural columns, proper court clearances are not being provided and are a safety concern if the court is utilized for traditional game play.

- **EXTERIOR**
  - The main entries have apparent foundation settling issues visible in the cracking brick. Some of this may have been caused by the improper roof drainage that is occurring over these covered entries. Water does not appear to be draining away from the building properly.

- The exterior windows overtime have been covered up with sheet metal coverings. It's not clear if insulation was added behind the sheet metal or if this was in lieu of replacing windows.

- An Ice and water shield type product has been used as an exterior cladding finish on the upper clearstory portions of the exterior façade. This material's intended use is as an underlayment or flashing, not something that can stand up to UV and driving moisture such as wind, rain or hail.

- There are some drainage concerns in the NE corner of the property and building. The adjacent site slope directly to this corner causing a potential low spot where the building could collect water.

- **SUMMARY**
  - The Rose recreation facility is a beautiful building that has historical value which may be worth saving. The overall facility has significant occupant safety and egressing concerns that should be addressed if it's continued use as an assembly space remains. The overall envelope of the building has noted energy inefficiencies that likely should be addressed as well for user comfort and reduced operating expenses.

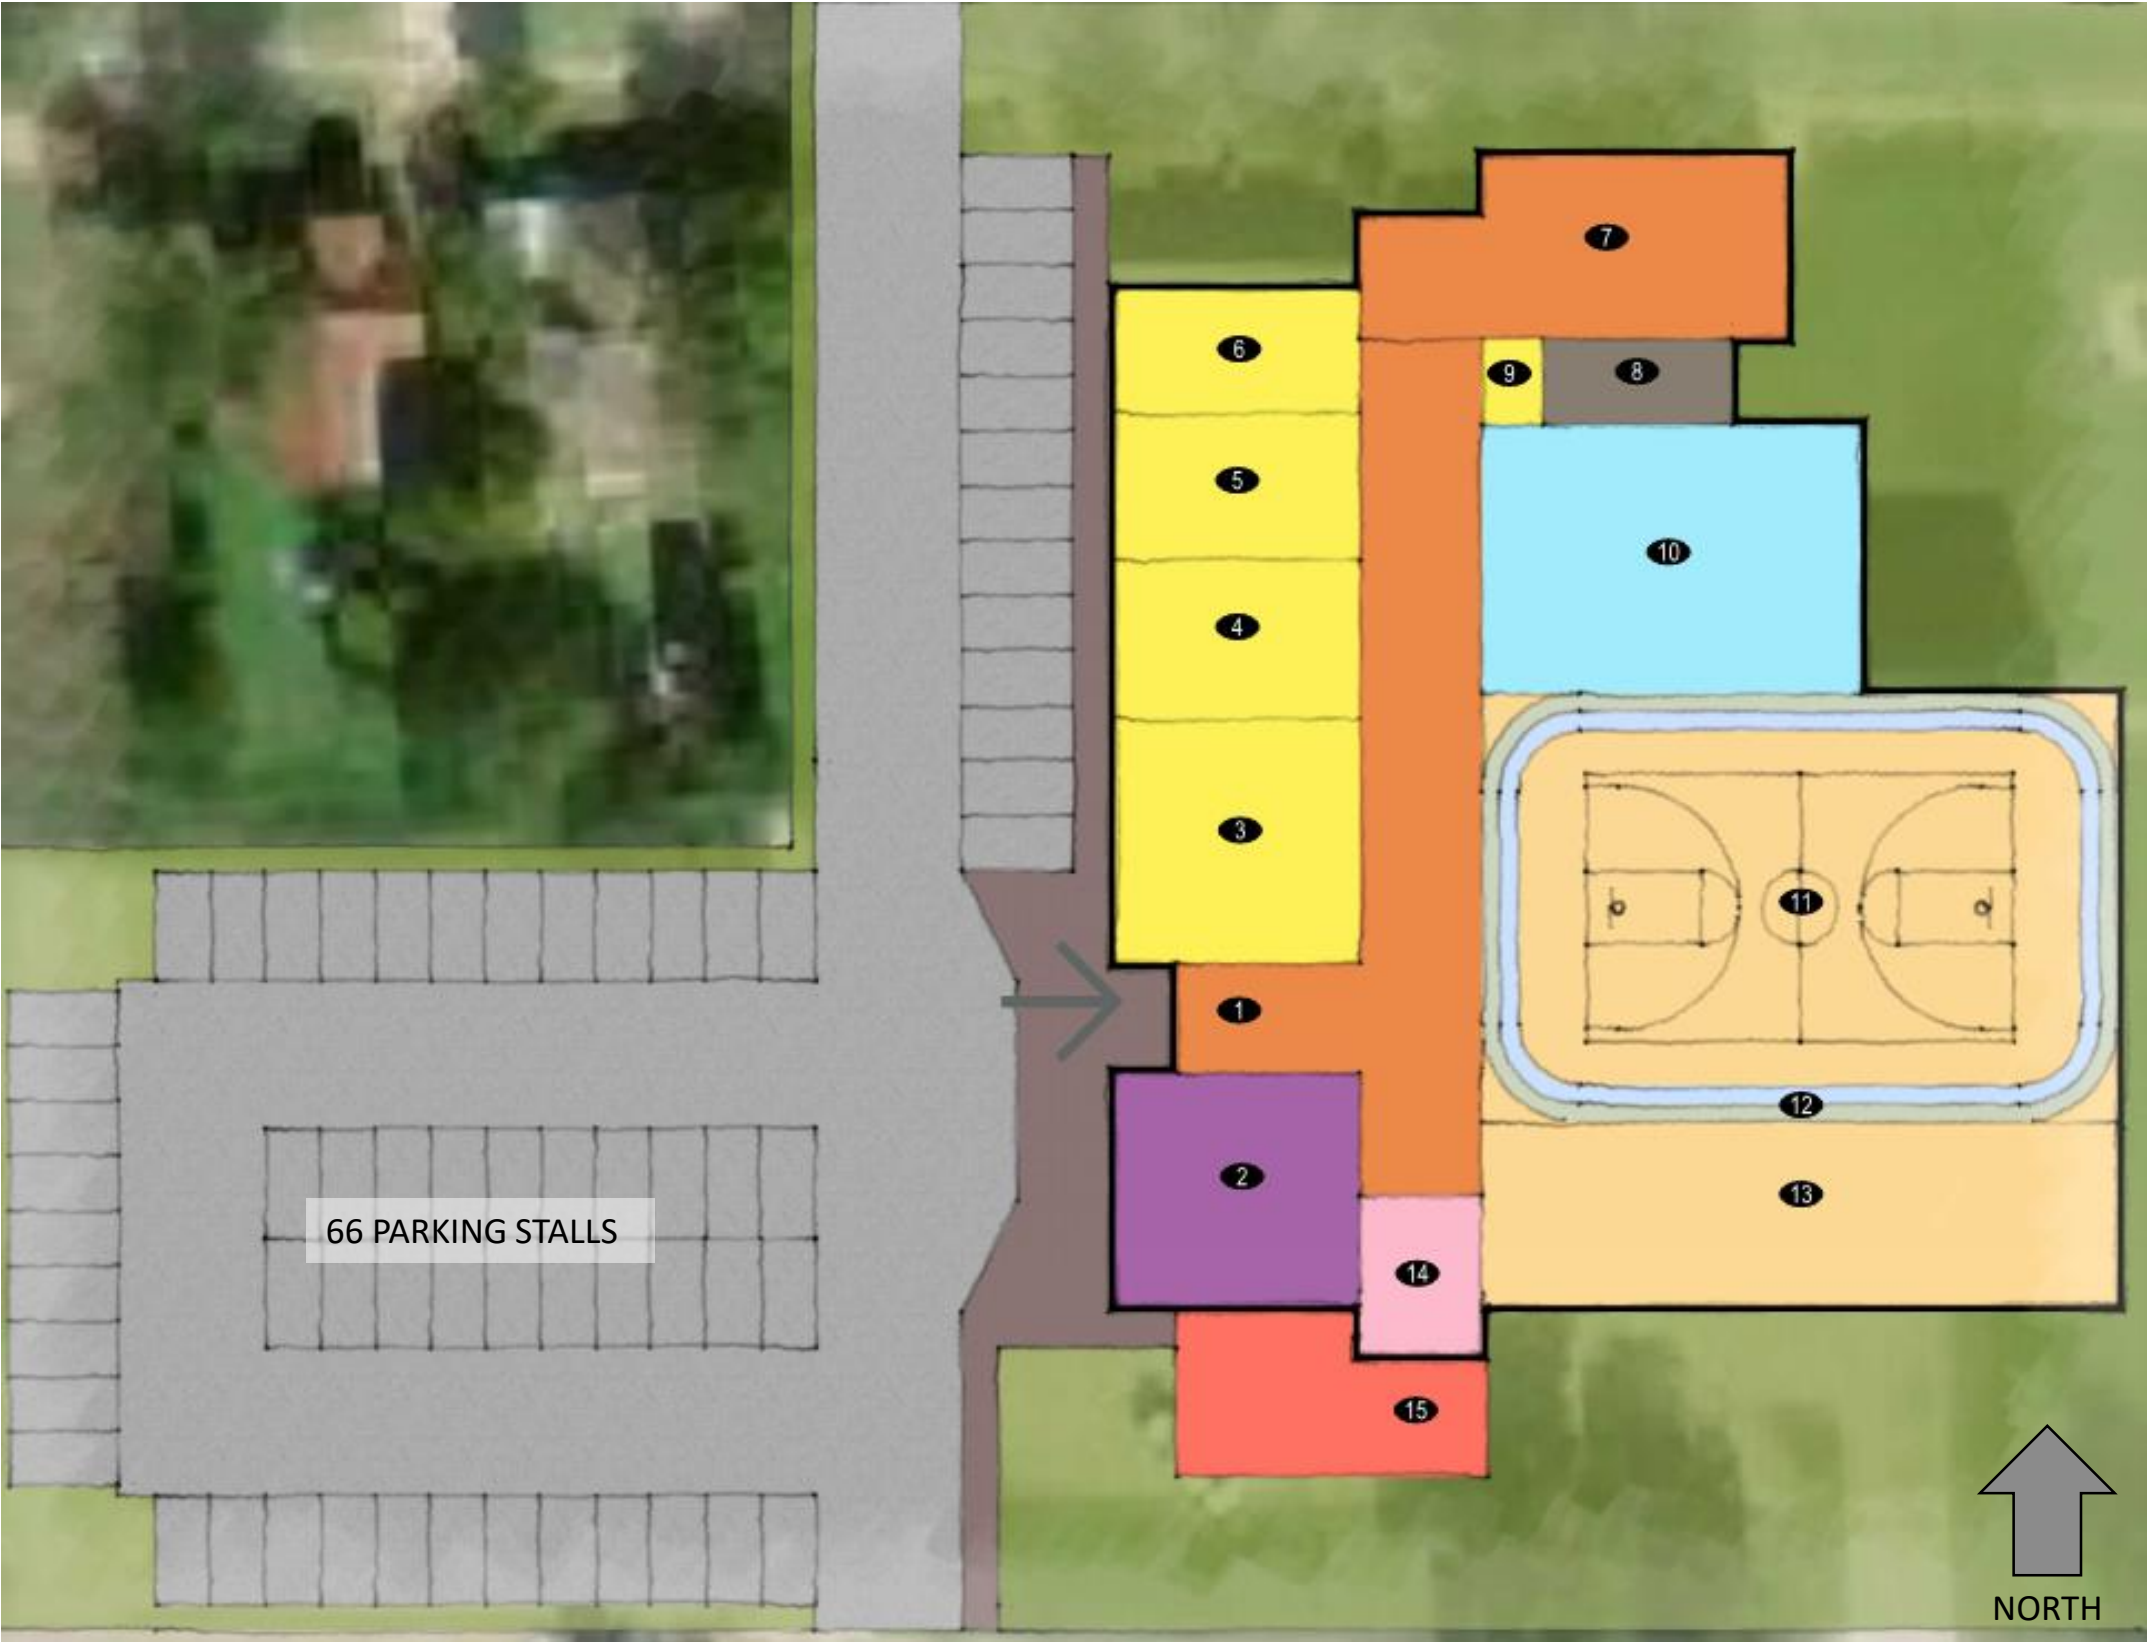
# ENHANCED EXISTING FACILITY CONCEPT – GV DANIELS RECREATION CENTER @ CARVER PARK

\*These conceptual drawings are subject to design modification as the project information, budget, schedule and priorities are future refined.

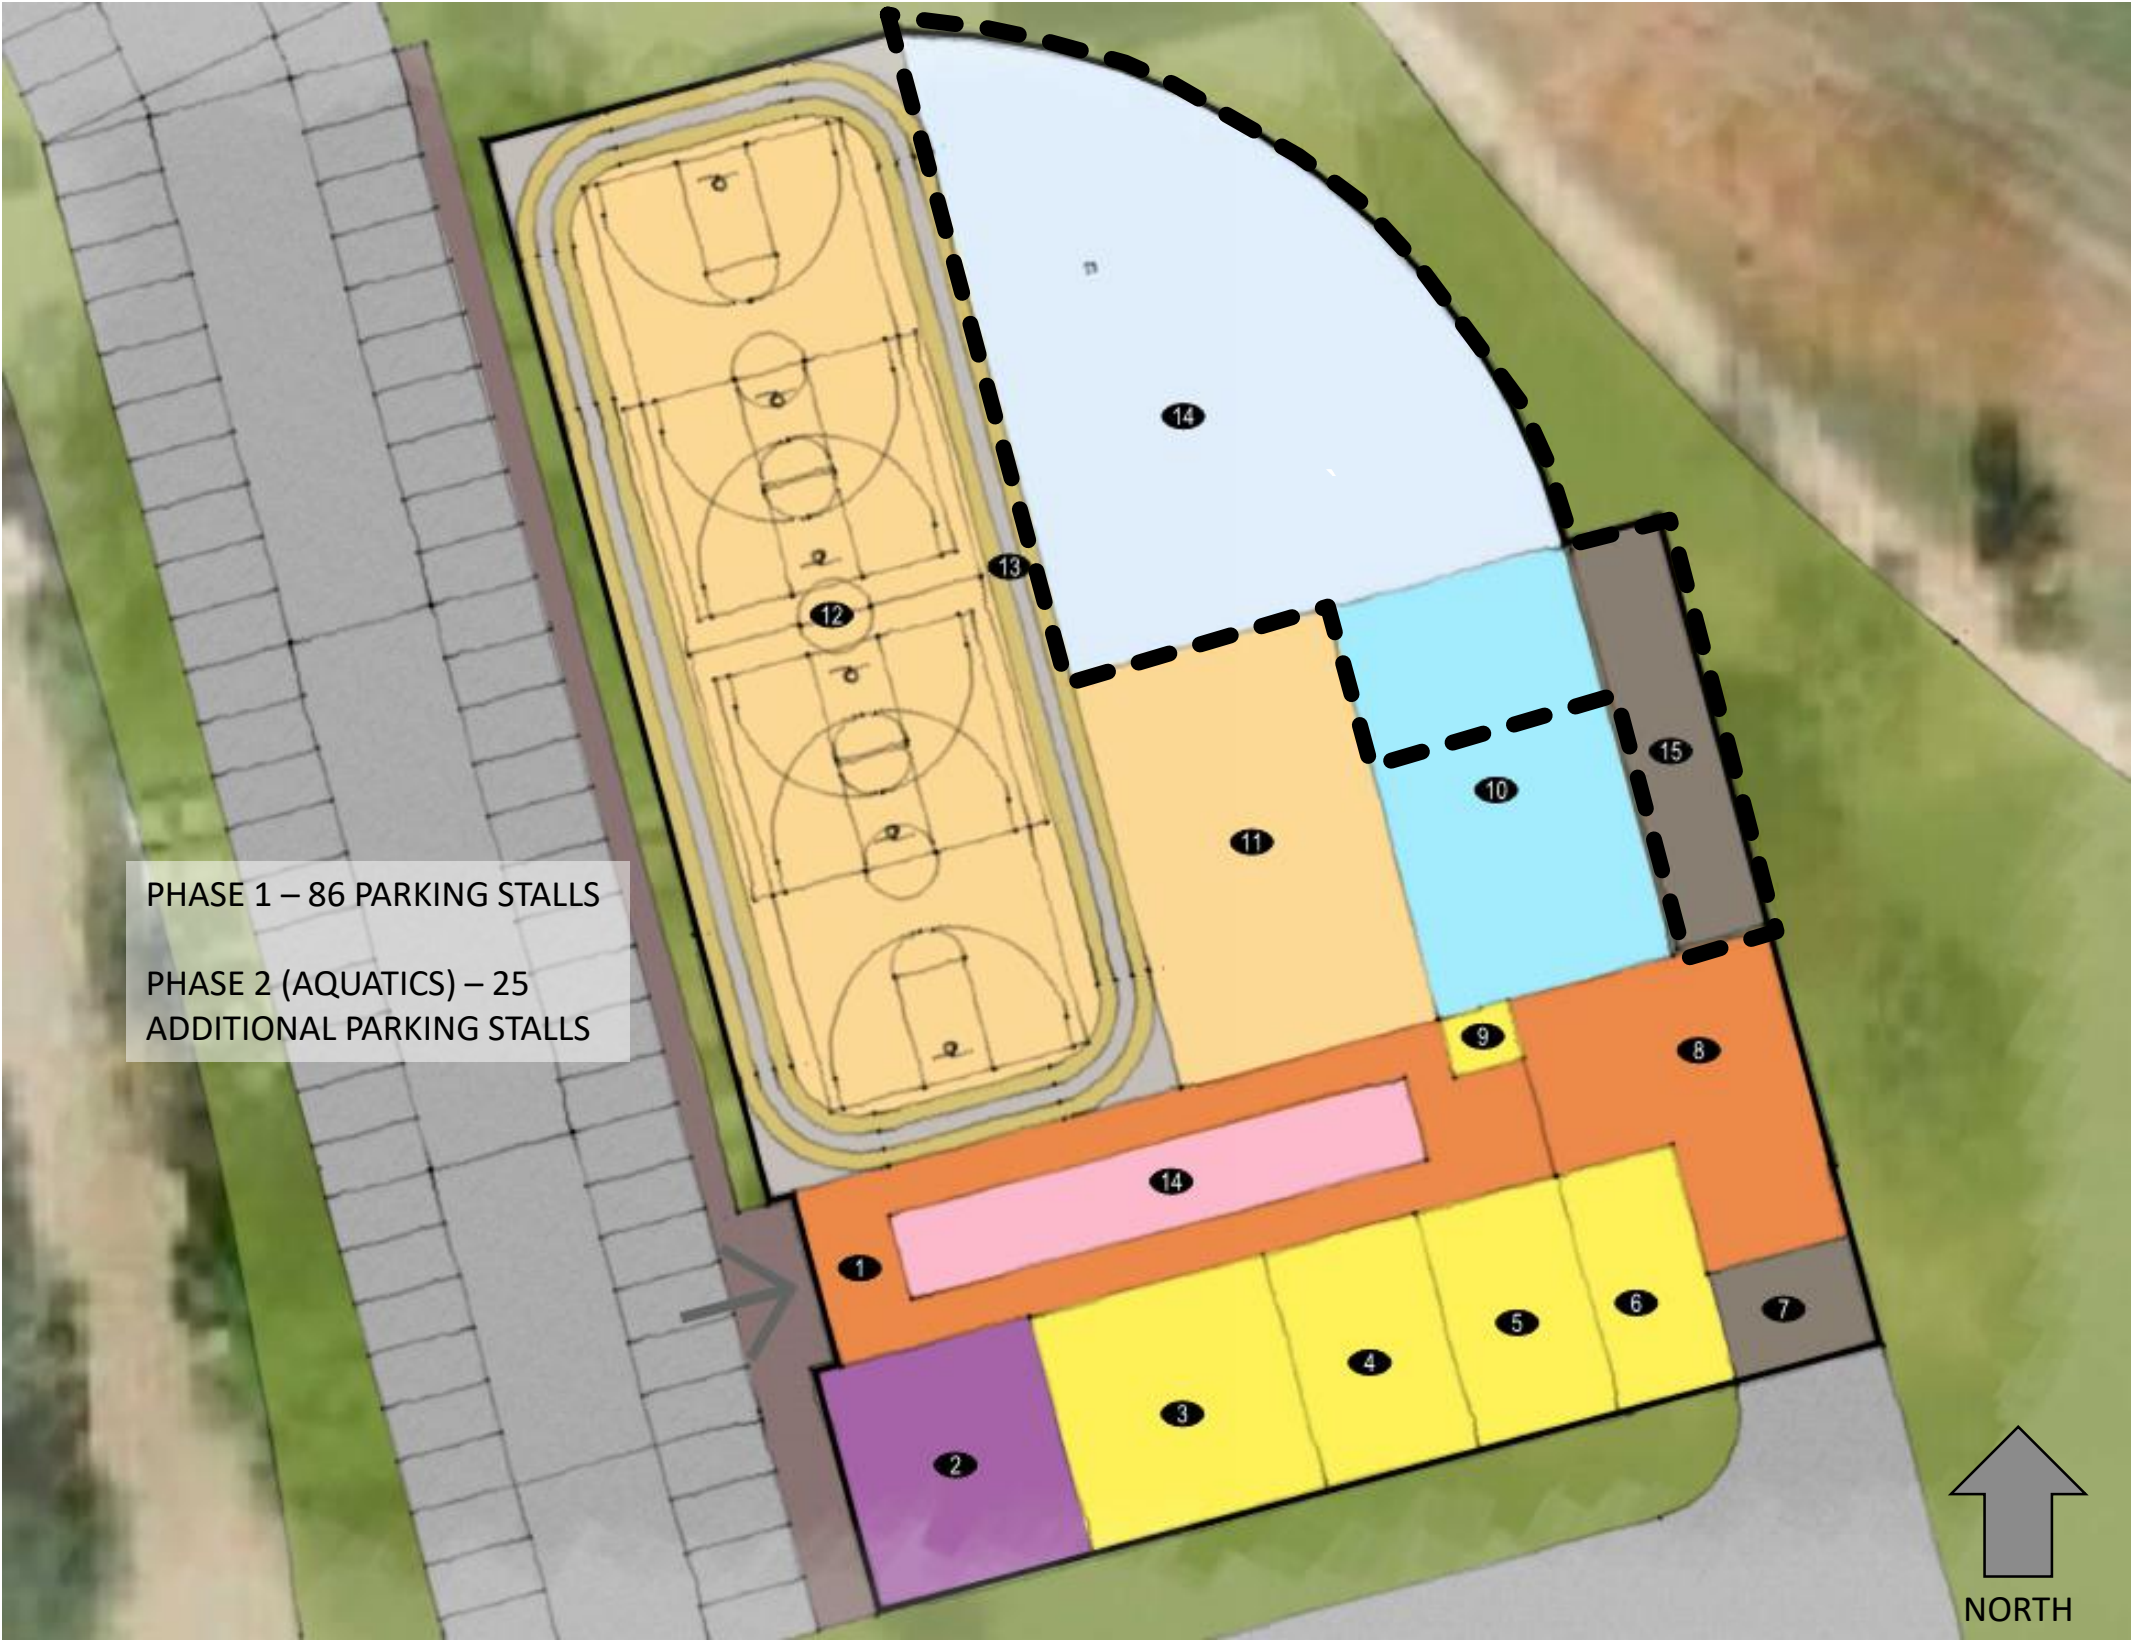
# ENHANCED EXISTING FACILITY CONCEPT – SEARS RECREATION CENTER @ SEARS PARK

- BASE PROGRAM - PHASE 1:**
- 1. ENTRY/ LOUNGE/ CIRCULATION
  - 2. ADMINISTRATION
  - 3. YOUTH / GAMES ROOM
  - 4. WET ARTS & CRAFTS ROOM
  - 5. CLASSROOM/ PARTY/ DRY CRAFT ROOM
  - 6. 25 PERSON CLASSROOM
  - 7. HEALTHY COOKING / PREP KITCHEN
  - 8. SENIOR LOUNGE
  - 9. GROUP TECHNOLOGY SPACE
  - 10. LOCKER SPACES
  - 11. FITNESS & WEIGHTS
  - 12. GYMNASIUM
  - 13. ELEVATED WALK/ JOG TRACK
